Rodney Square Building Restorations, Inc.

February 26, 2010

RE: [REDACTED] Wall Repair

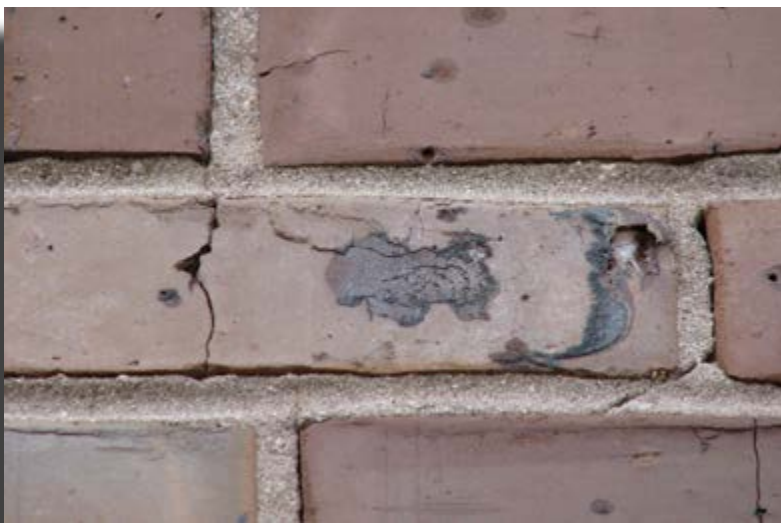
At least one significant leak source is broken brick and mortar joints (Fig. 1). It may be the only source. During the inspection that was conducted during the rain and wind event in January water was found on the inside of the brick (Fig. 2). From there it traveled to the top of the window frames and ceiling grid and then into the offices.

Fig. 1 - Broken Brick & Open Mortar Joints

Best practices and guidelines offered by the American Brick Institute direct the starting point for remediation of leaking brick walls is repair or replacement of broken brick and re-pointing of failed mortar joints.

The first thing to do is rig a two point, swing stage scaffold at the south end of the building and repair the broken wall above the suite on the top floor in that corner. The repair would consist of chipping and / or grinding out the broken mortar joints and replacing the mortar and creating new joints at places where the brick is cracked or replacing the brick. This is a standard “tuckpointing” process which we’ve completed on many projects in the past.

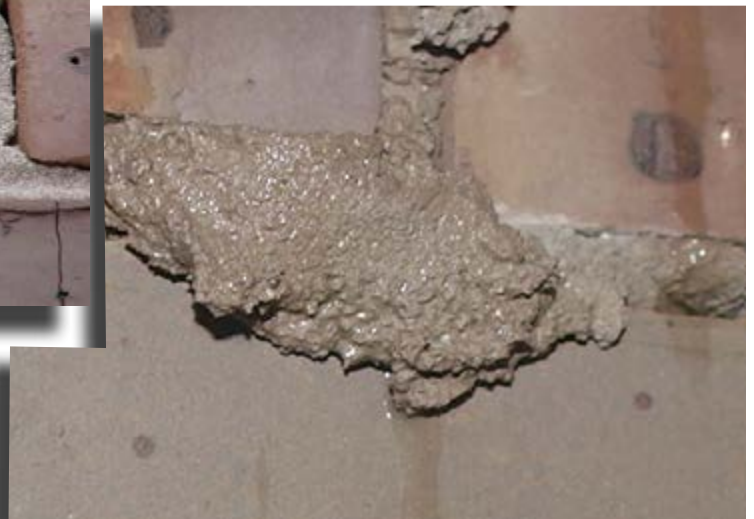
Fig. 2 - Soaked Mortar On Inside Of Wall

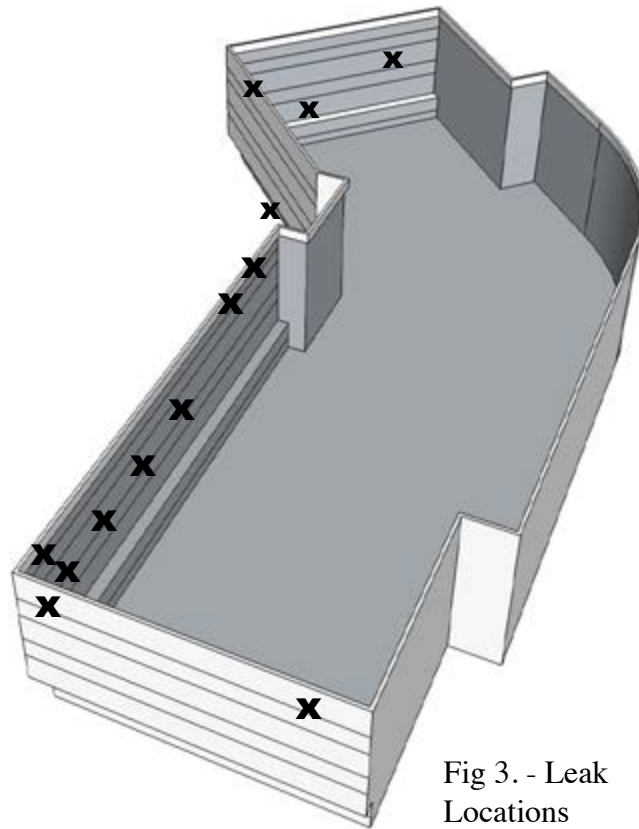
Leaks were found at the locations indicated in Fig. 3.

Fig 3. - Leak Locations

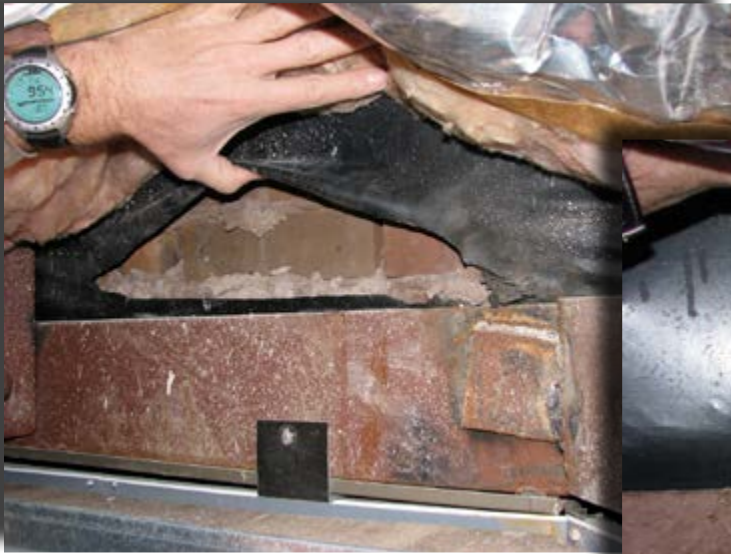
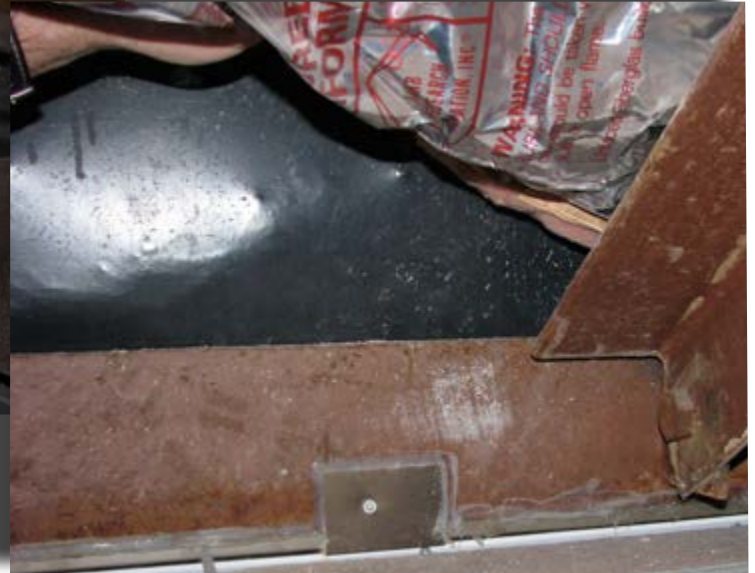
Fig. 6

Figures 6 and 7 are pictures of the wall above one of the upper floor ceilings at [REDACTED]. There is no cavity between the vertical leg of the brick shelf angle and the brick as shown in Figures 4 and 5. Water that penetrates the brick above this point flows down the plastic vapor barrier until it reaches the top of the shelf angle. Some of that water will flow to the bottom course of brick and out the weeps. During heavy, wind blown rain the amount of water exceeds that which can bleed through the confined space behind the brick. The excess water gets out somewhere else and flows to the inside.

Given that the wall was improperly assembled the choice of which approach to take isn’t easy. Since water can’t escape through the weeps as it should even small breaks in the wall result in leaks to the inside. If the weeps were working that wouldn’t be the case.

3. Clean out all weeps by drilling through the existing opening from the outside face of the brick to the shelf angle behind the brick.
4. The same conditions and estimates apply to any other portions of the building we may be asked to remediate in the same fashion.
