Harvard Corporate Center

Buildings Condition Assessment

February 5, 2015

JVS Building Services, LLC 5012 Killens Pond Road Felton, DE 19943 302-632-4972

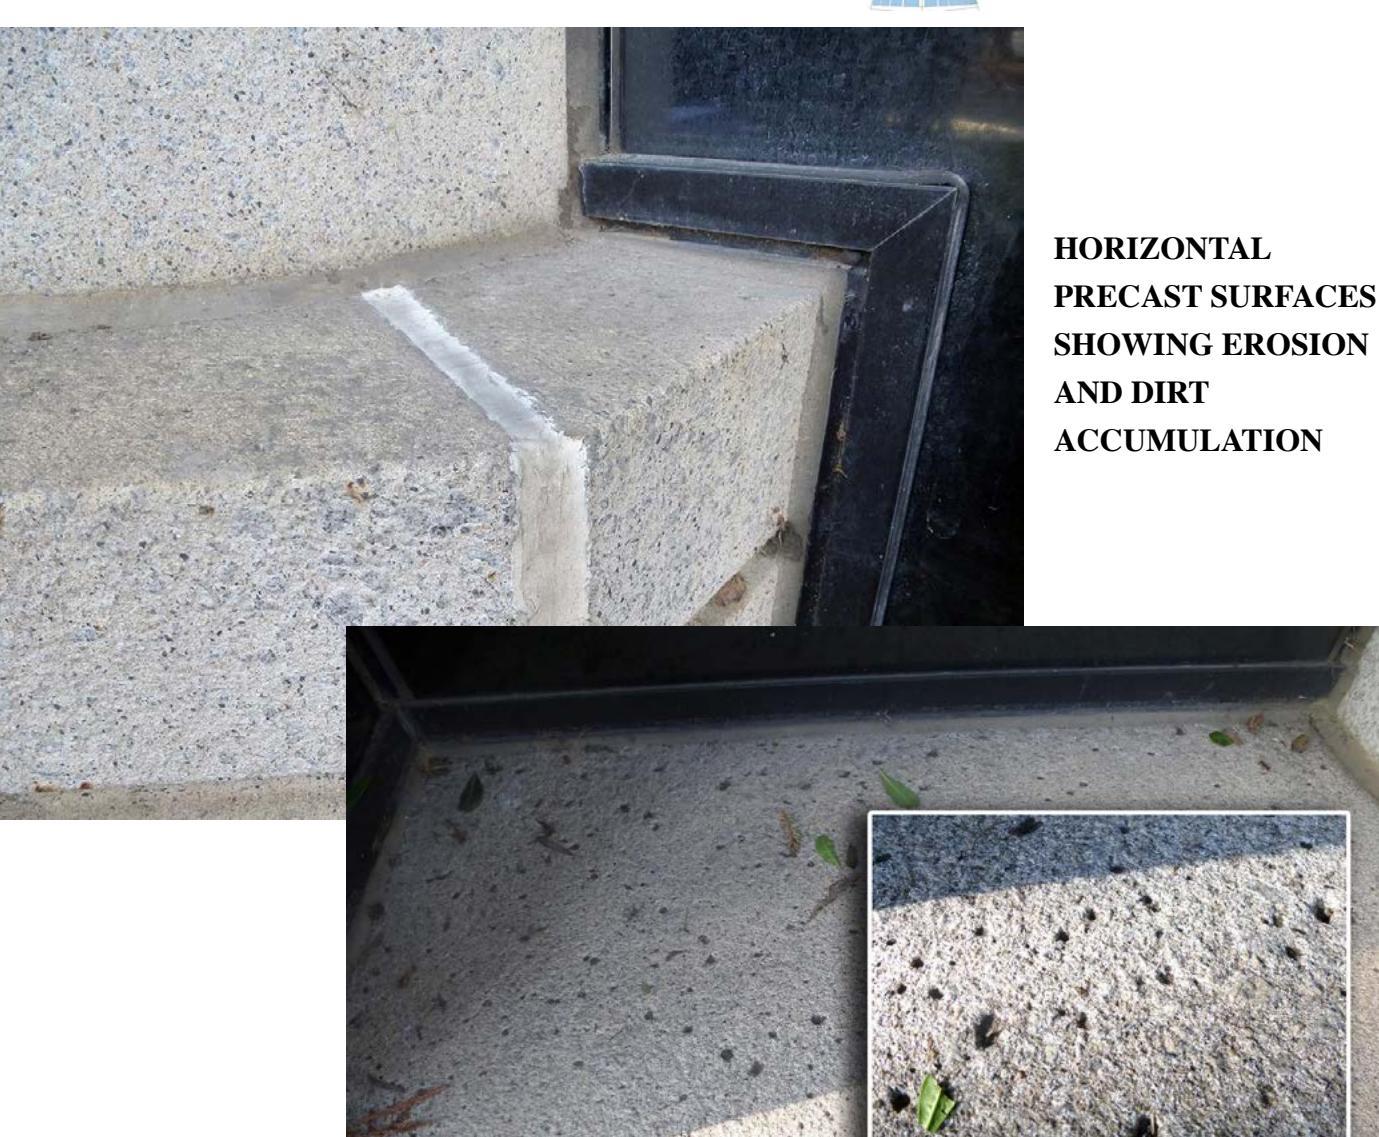
The precast concrete building elements are sound with only one incidence of spalling, one minor crack and no other forms of subsurface defects observed.

The precast surfaces are porous and readily absorb water. The vertical precast surfaces are still clean from the recent pressure wash but the horizontal surfaces on the upper floors are quite dirty. Some horizontal surfaces are eroded. Waterproofing and / or coating of the precast is recommended. The least expensive yet highly effective method would be to apply a penetrating sealer. These surfaces could also be painted with a coating that will adhere to the silicone joint sealant although this will introduce another maintenance requirement. Another alternative is a silicate, mineral paint. This a very low maintenance solution that will allow the introduction of color without the need for periodic re-application of the coating.

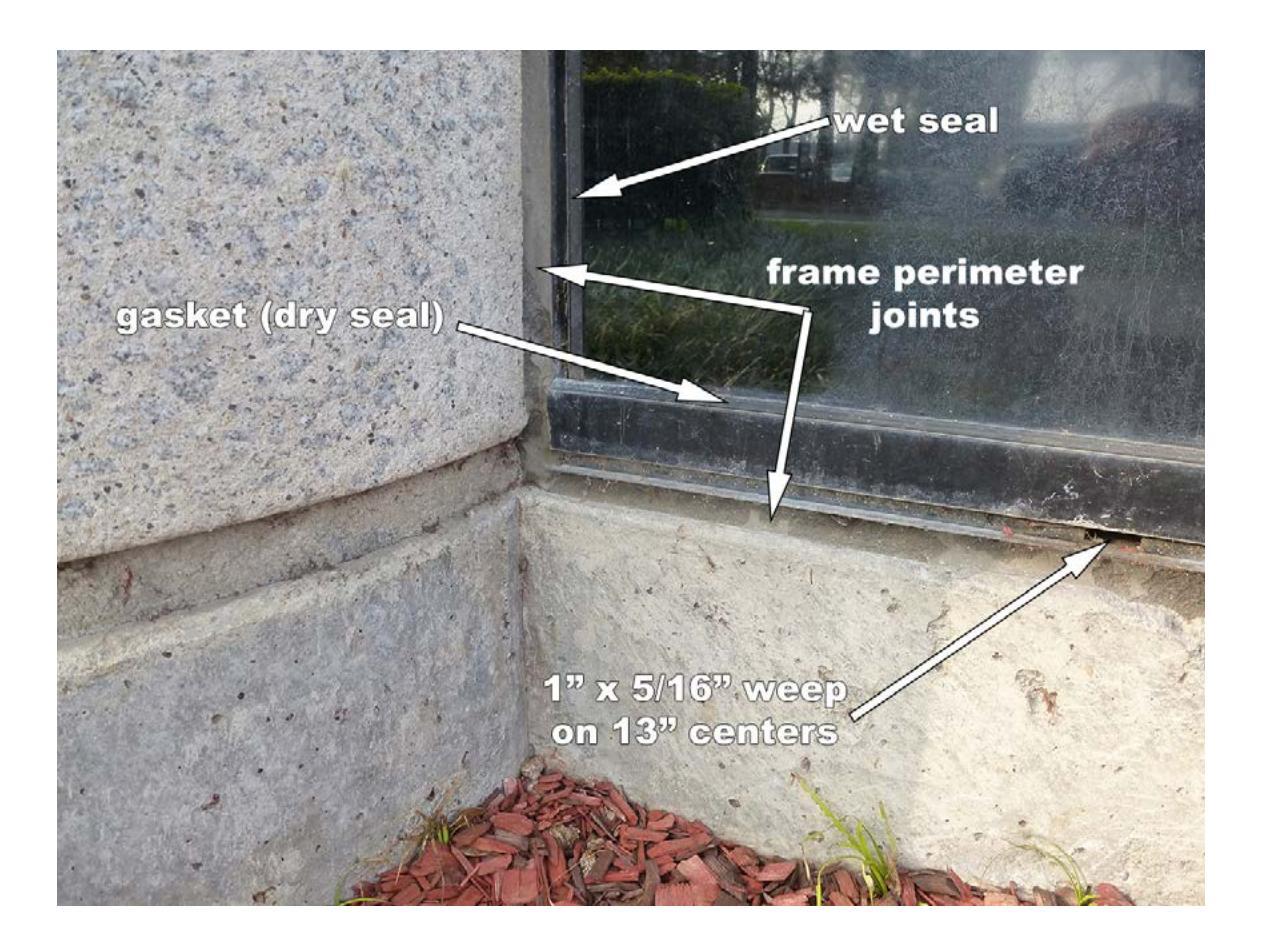
The window and storefront perimeter joints appear to date from the original build and they are deteriorated. There are few, if any, adhesive failures but there are extensive surface defects, which in some cases have progressed to openings in the joints. Although pervasive failure does not appear to be imminent all of these joints should be replaced in the near future.

The window perimeter joint on the ground floor of the Northwest wall of Building One is missing. Backer rod was installed but there is no sealant.

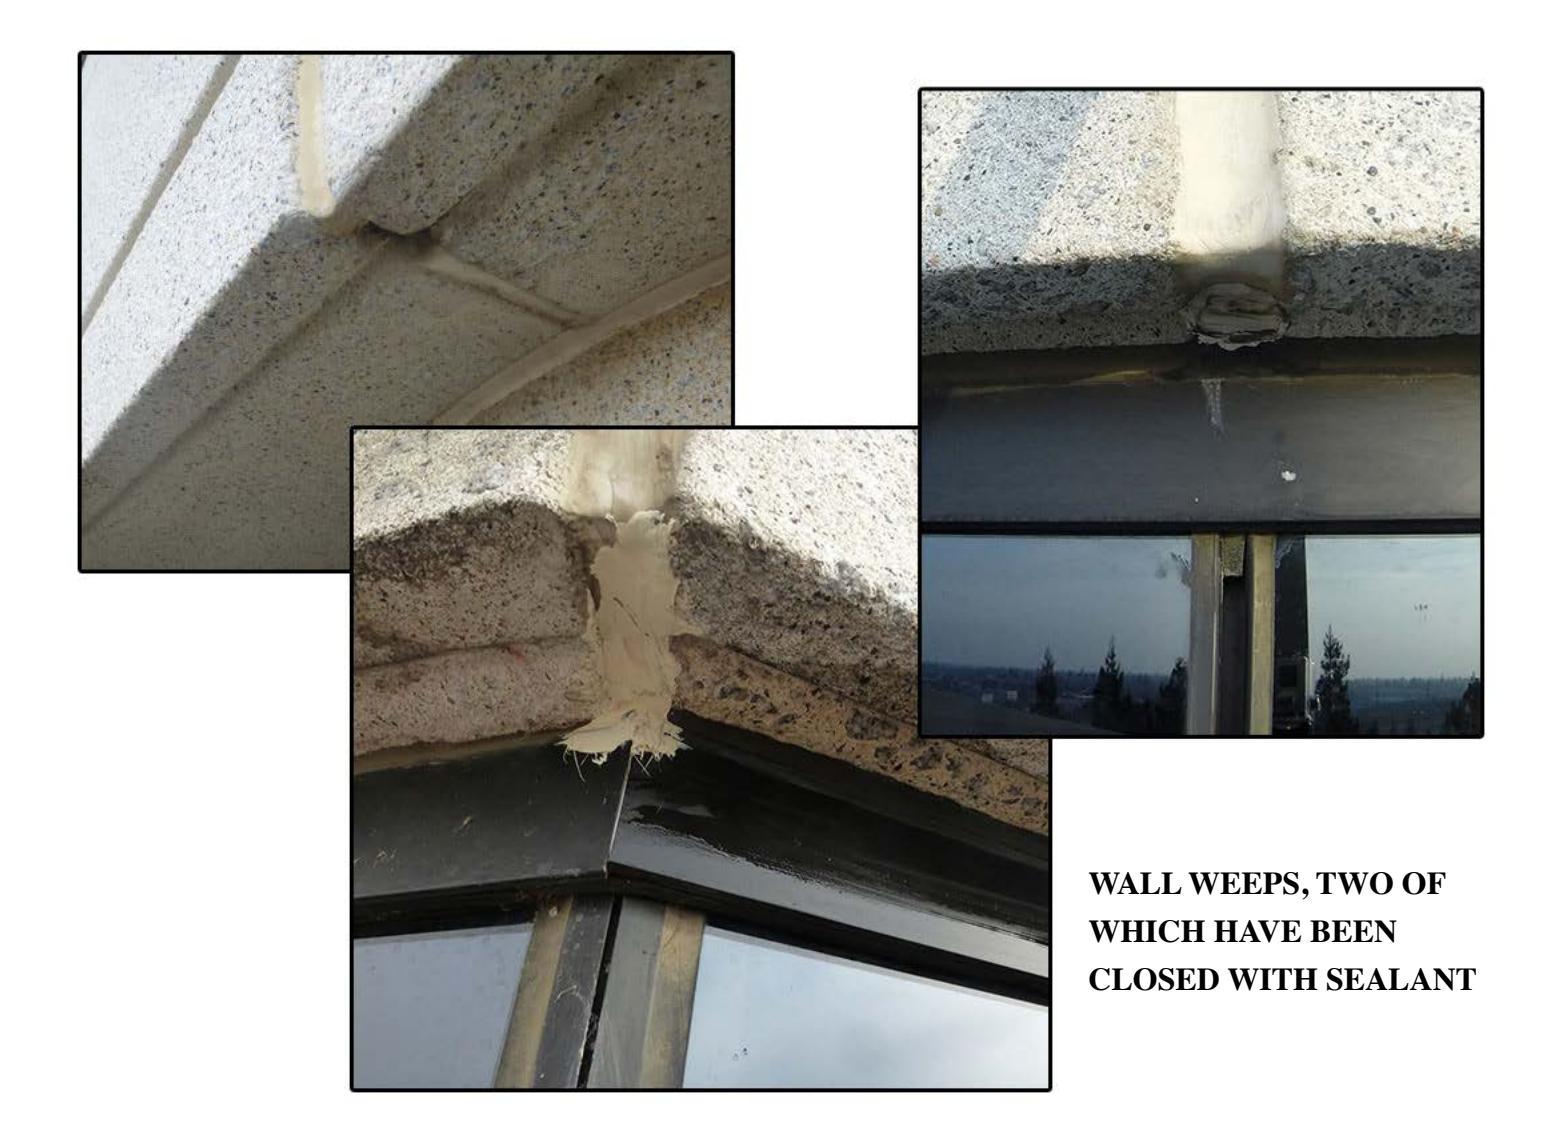
Originally, openings at the bottoms of the precast panels were provided to allow water that penetrated the envelope to escape. To bar the entry of stinging insects the window cleaners were tasked to fill these opening with sealant. The efforts of the exterminator or other factors could account for it, but closing the weeps as they did may have been a factor in the near elimination of the infestation.

The conditions that the weeps were intended to address apparently did not exist until now because there's been no evidence of water penetrating the walls and making its way into either building. Obviously, closing the weeps has had no detrimental effect. However, since weeps that exclude insect entry while allowing water to escape are available they should be installed when the precast sealant is replaced.

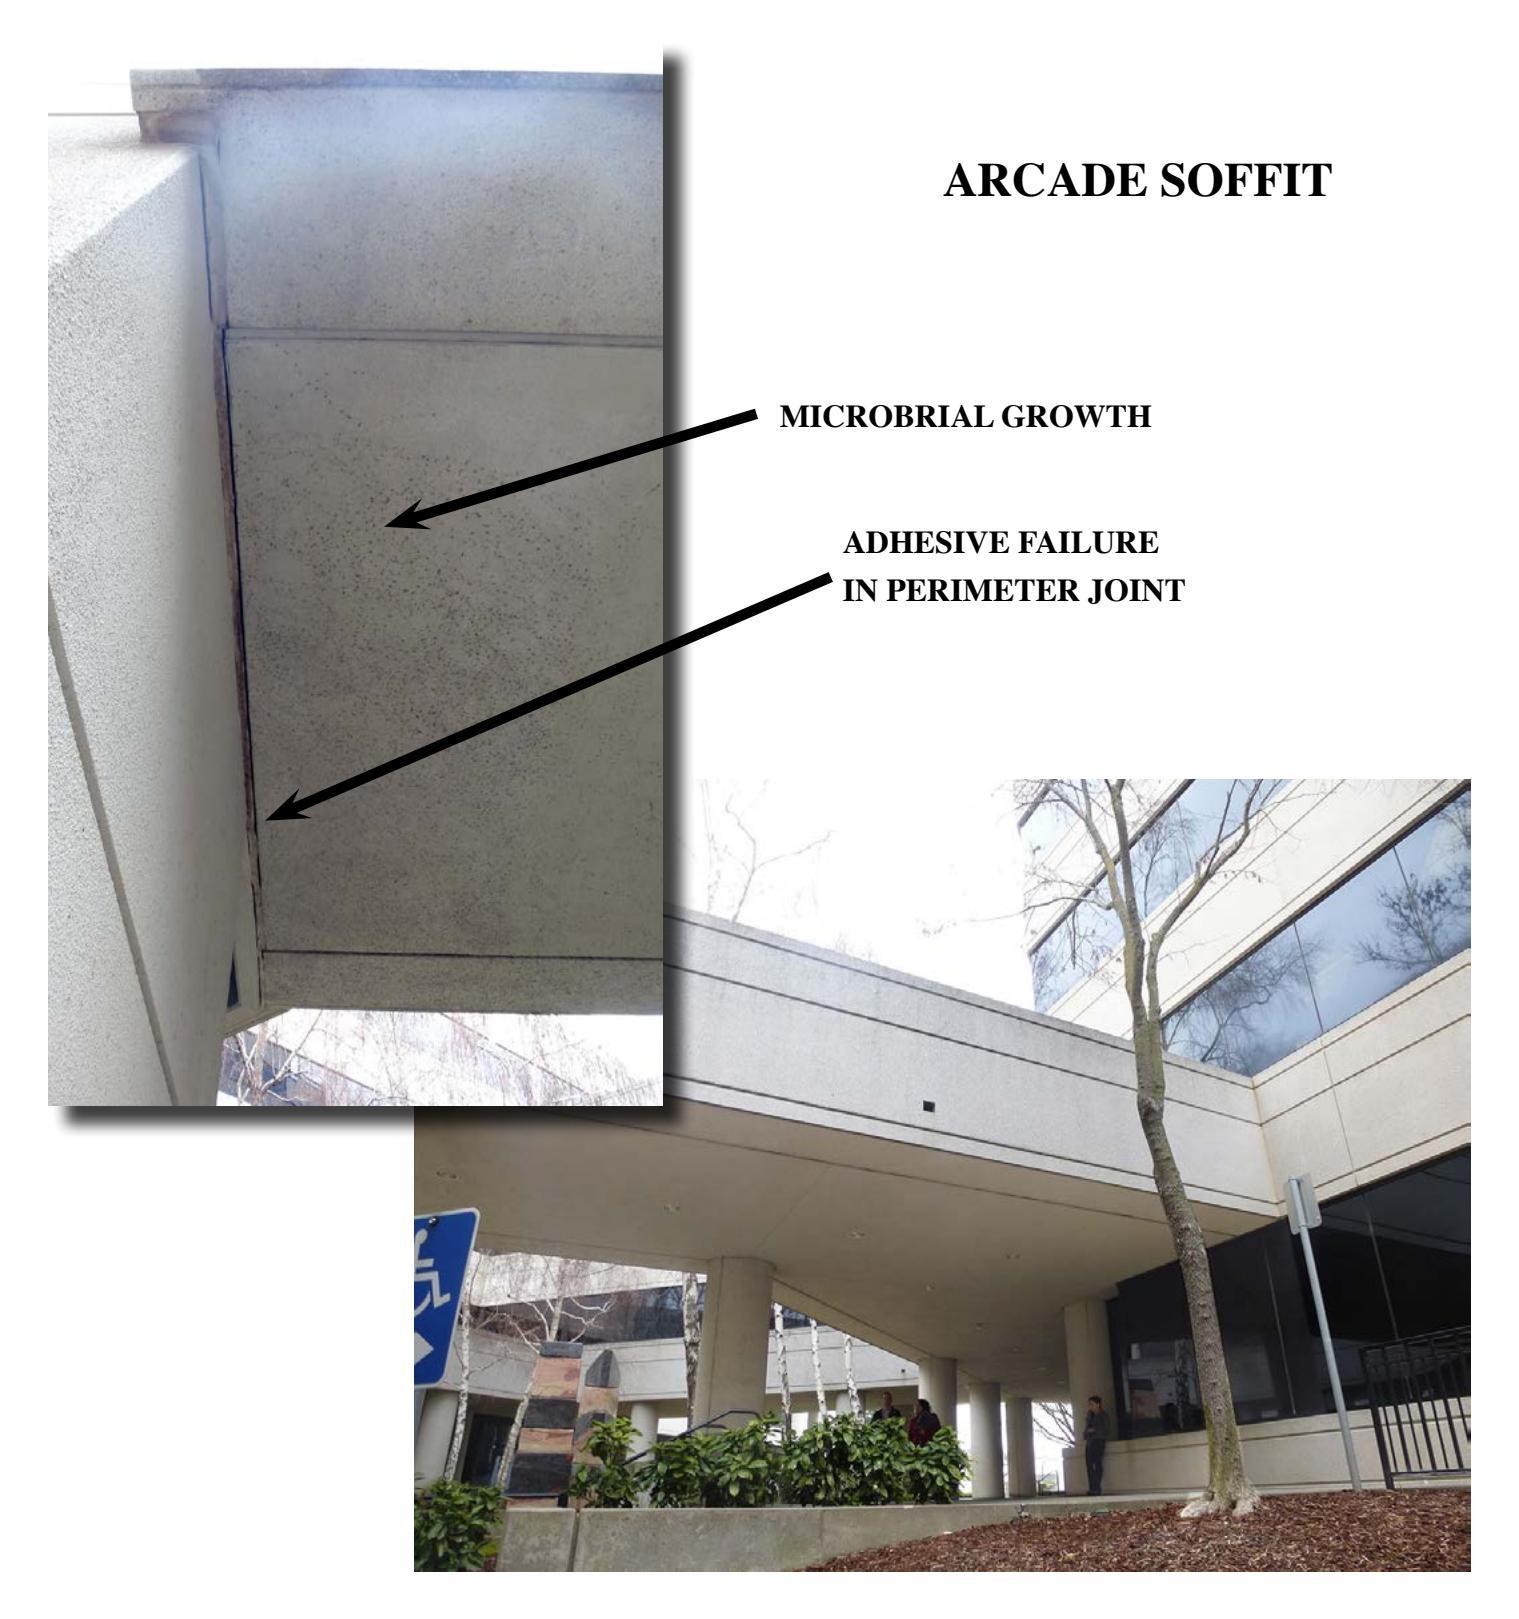
Currently, the Arcade soffit surface and the surfaces of the soffits over the entrances to both buildings are in fair condition. They all, however, could benefit from, and will eventually need to be coated with anti-microbial paint.

The perimeter joints around the Arcade soffit need to be restored as do the joints between the cement board components of this soffit. There is extensive adhesive joint failure in these joints. (See the previous image.) This could be corrected by using sealant primer or a different material, perhaps a silyl-terminated oligomer (hybrid) sealant. The perimeter joints and the cement board joints in the soffit over the entrance to Building Two are in better condition. They are in the same category as the precast joint. They are not likely to fail anytime soon but if a sealant project is undertaken these joints should be included.

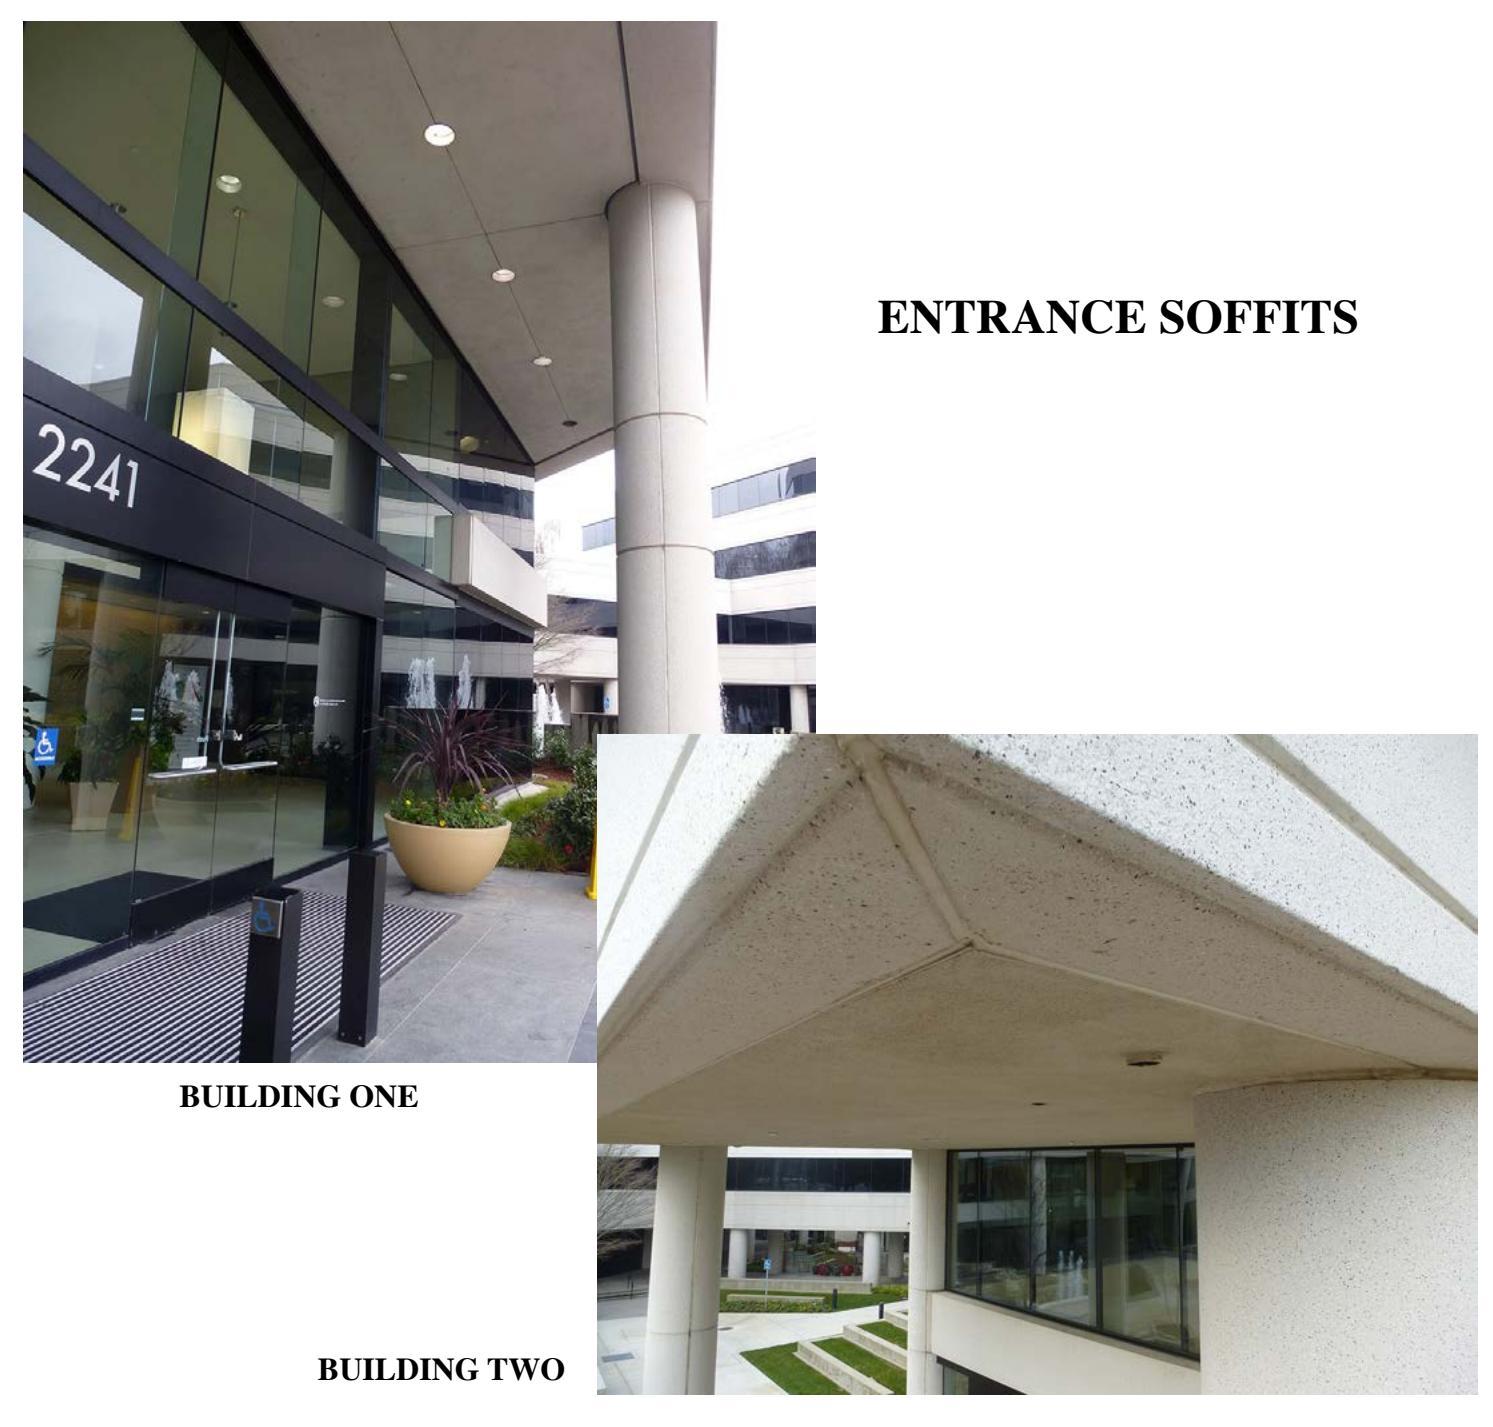
(Sealant is not installed between the cement board and the precast in the soffit over the entrance to

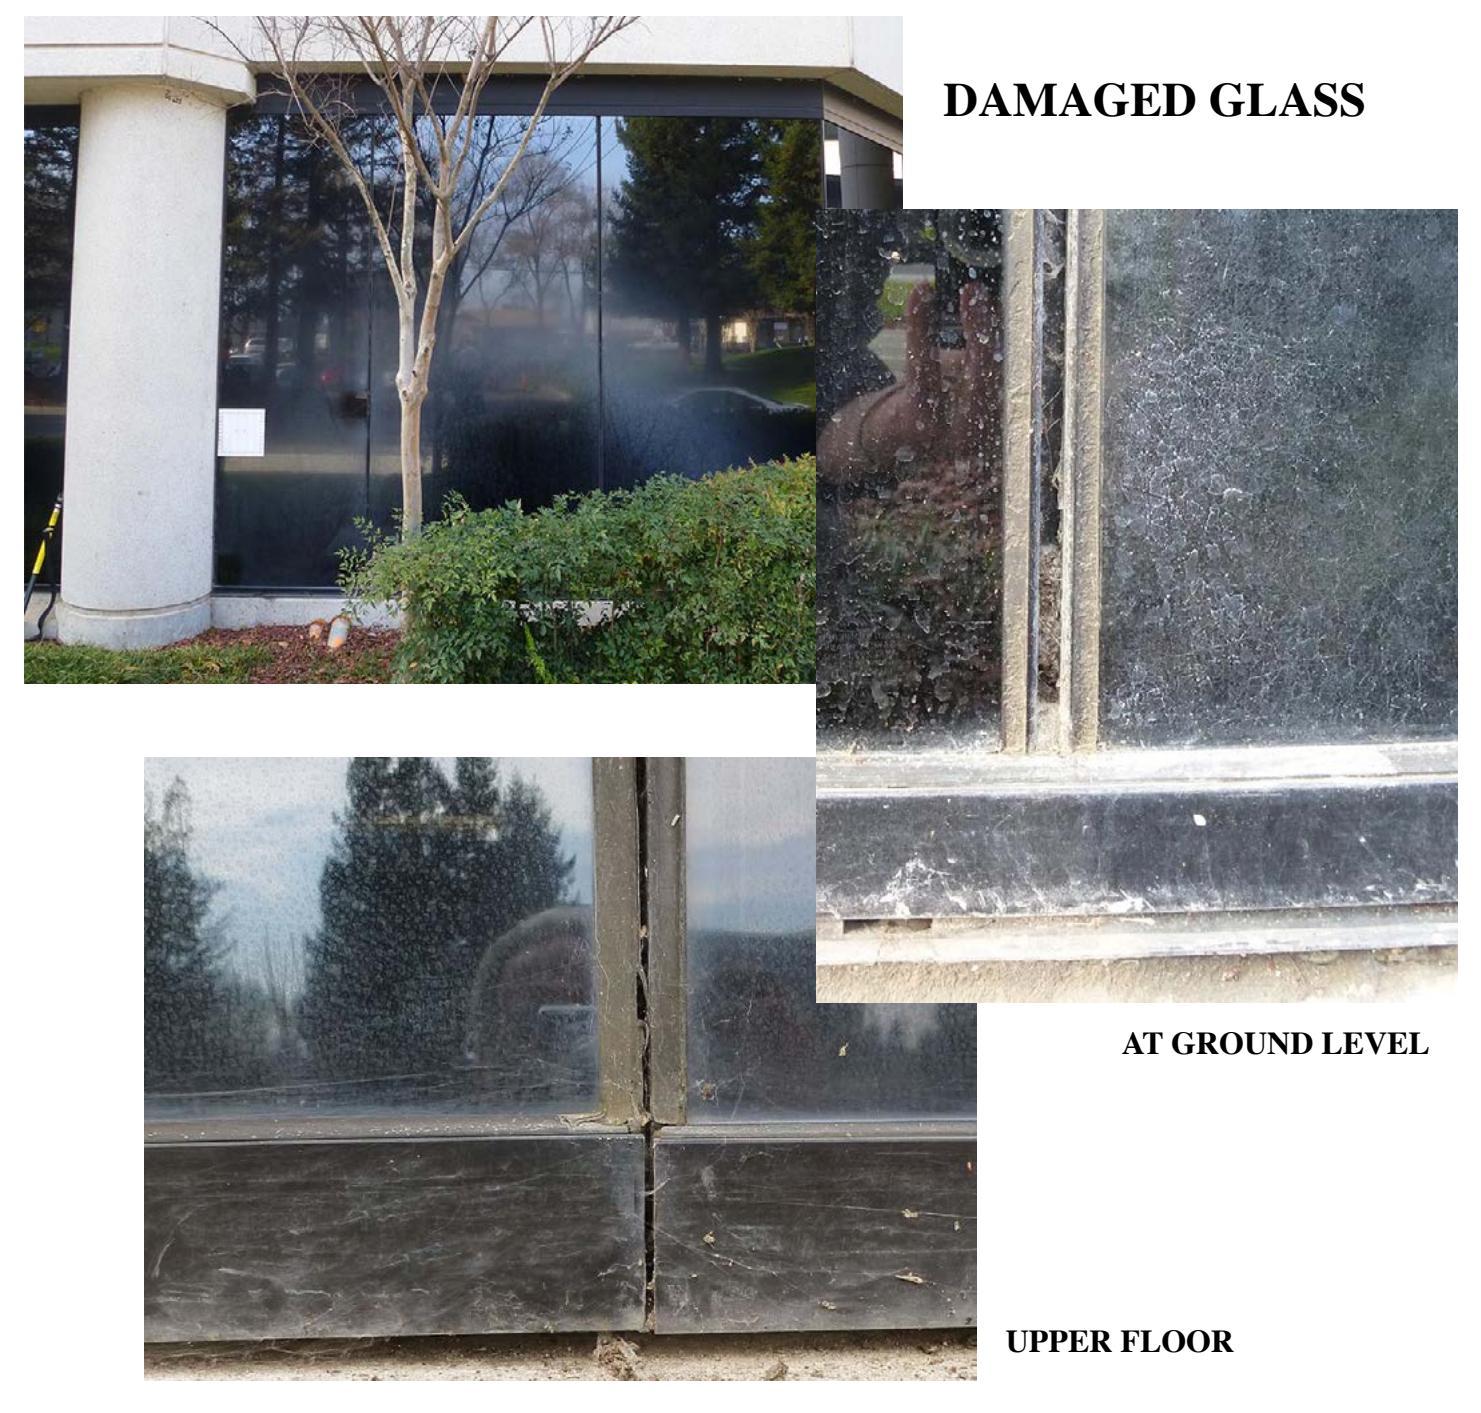
One of the first things one notices when approaching Building One is the damaged glass on the north end of the east elevation. Irrigation of the beds at the base of the wall has bathed the glass with mineral rich (hard) water which has reacted with the glass and damaged it. This condition exists to a lesser degree on many of the ground floor widows on both buildings. The glass on many of the upper floors is also slightly damaged or stained to a degree that normal cleaning will not remedy. If not cleaned or restored and sealed the glass will continue to degrade. Methods that restore glass to essentially new condition make glass replacement unnecessary and materials that seal the

surface and impart hydrophobic qualities keep the glass in good condition.

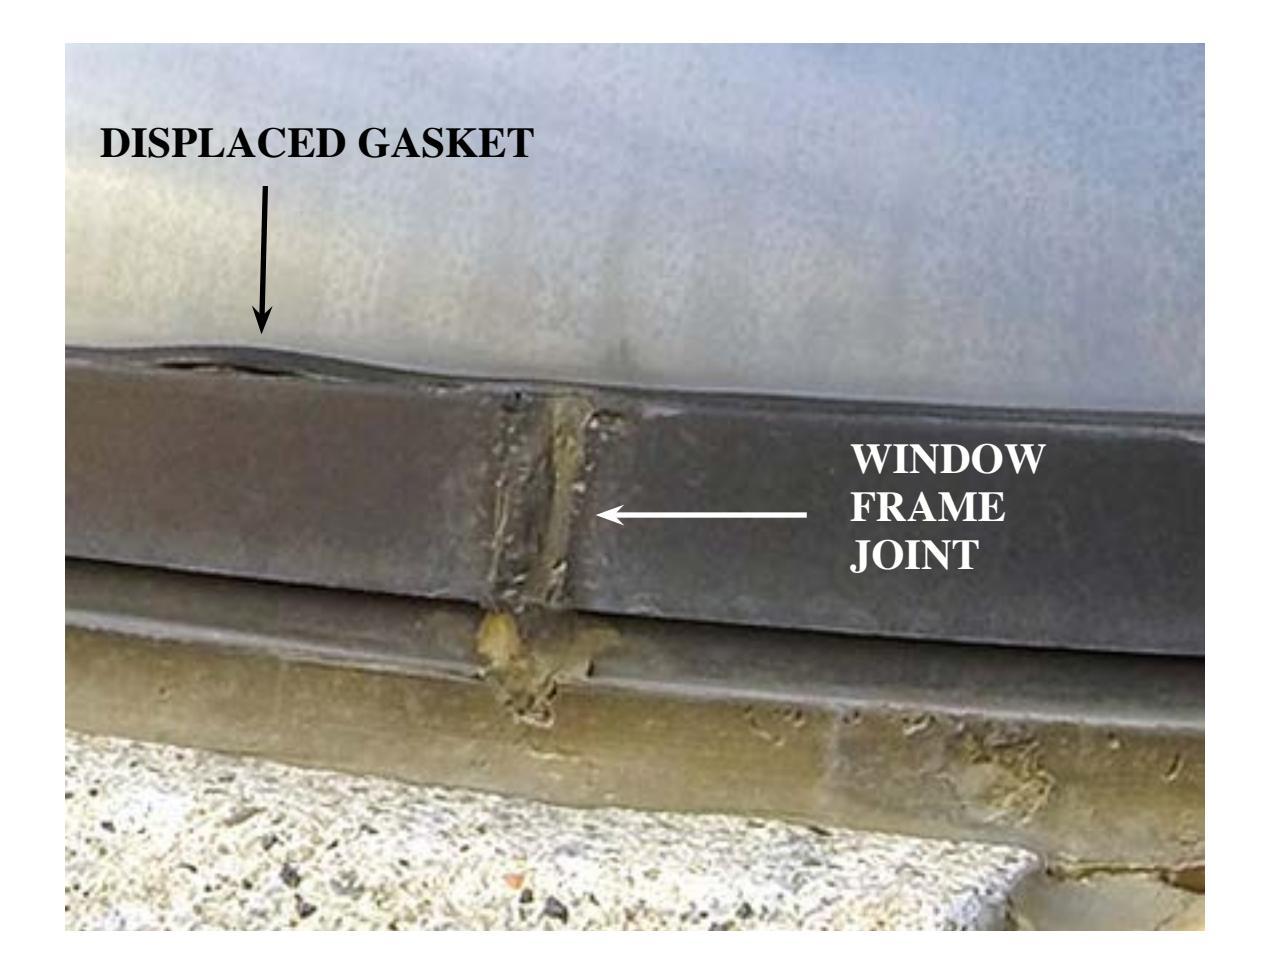
The spaces between the storefront frame elements are closed with sealant also. In the storefronts there are cases where a butt joint is the correct configuration. Where the frame elements are perpendicular to each other fillet joints were installed and in those cases that was the correct choice too. There are places however, where tape or a silicone extrusion should have been used and

Where the top and bottom horizontal frame elements meet the glass in both the windows and the storefronts gaskets secure the glass and seal the joint. Mostly, they are in good condition. Some are out of place over distances of a few inches (the previous image includes an example). In some cases they have contracted creating openings. Where either of these conditions exist they should be replaced with wet seals.

these changes should be part of the sealant restoration specification.

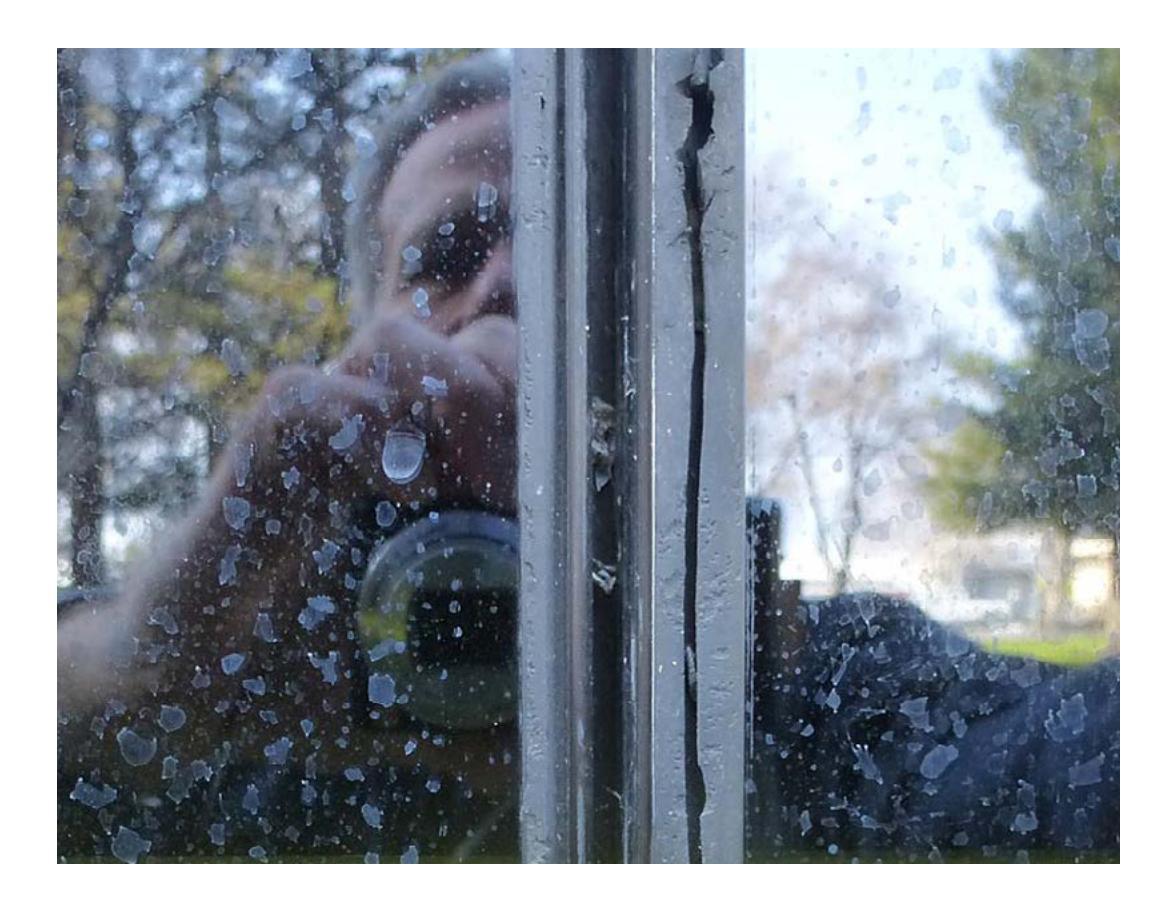
Where the vertical frame elements meet the glass, in both the windows and the storefronts, structural sealant secures the glass and seals the joint. Although it has not yet taken place in a significant percentage of these joints, cohesive and adhesive failure of the wet seals have occurred. Glass has broken recently at several locations throughout the buildings. The glass installer informed the building engineer that is due to "pressure" on the glass. (This is a reference to lateral force, not air pressure.) The failure of the wet seals may have relieved that lateral force. This may be an indication that a lower modulus sealant is called for.

The wet seals, in many locations, perhaps a majority, have surface defects too.

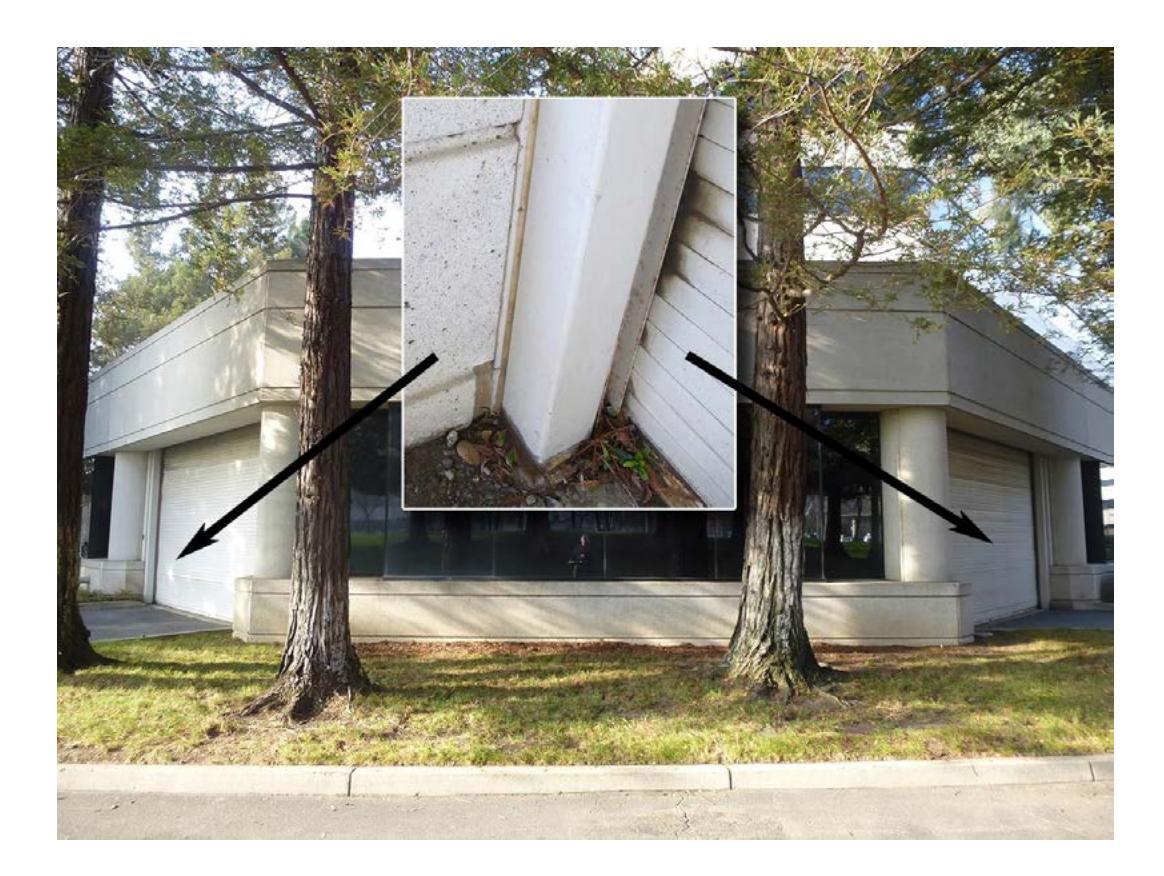
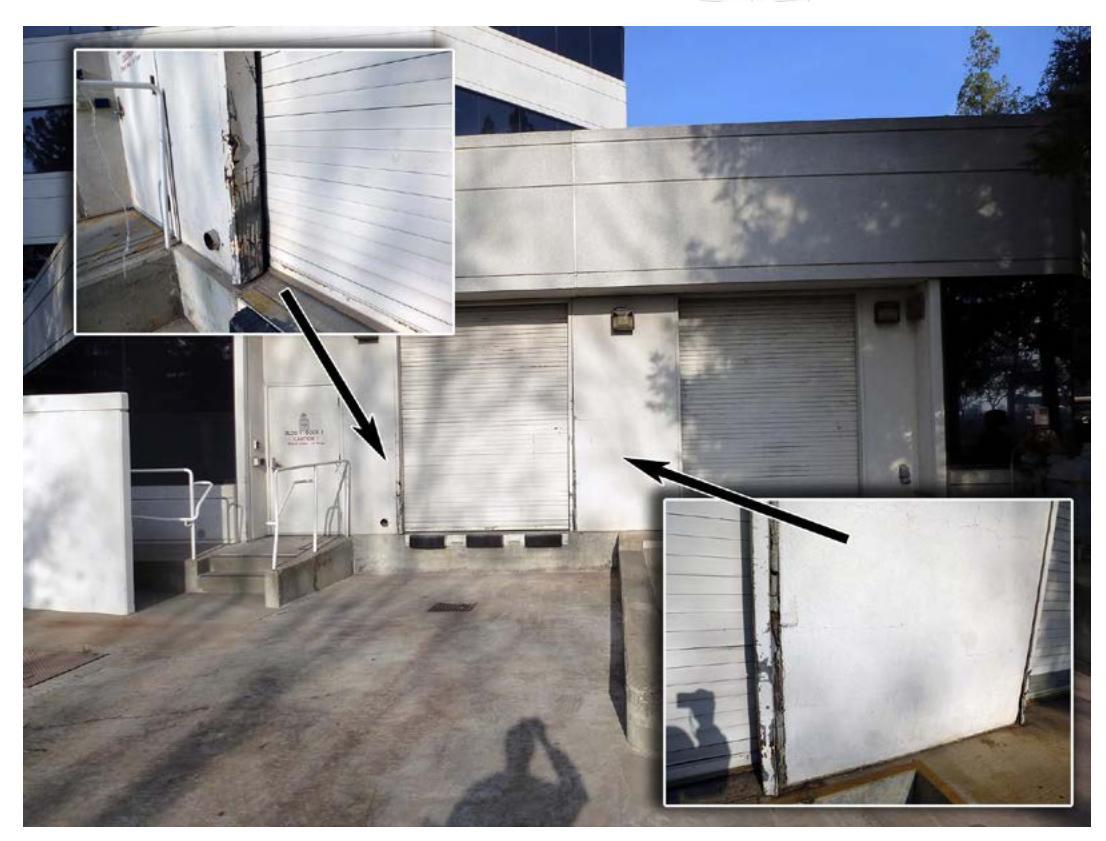
The roll-up doors at either end of the "Drive-up Claims Area" need fresh paint.

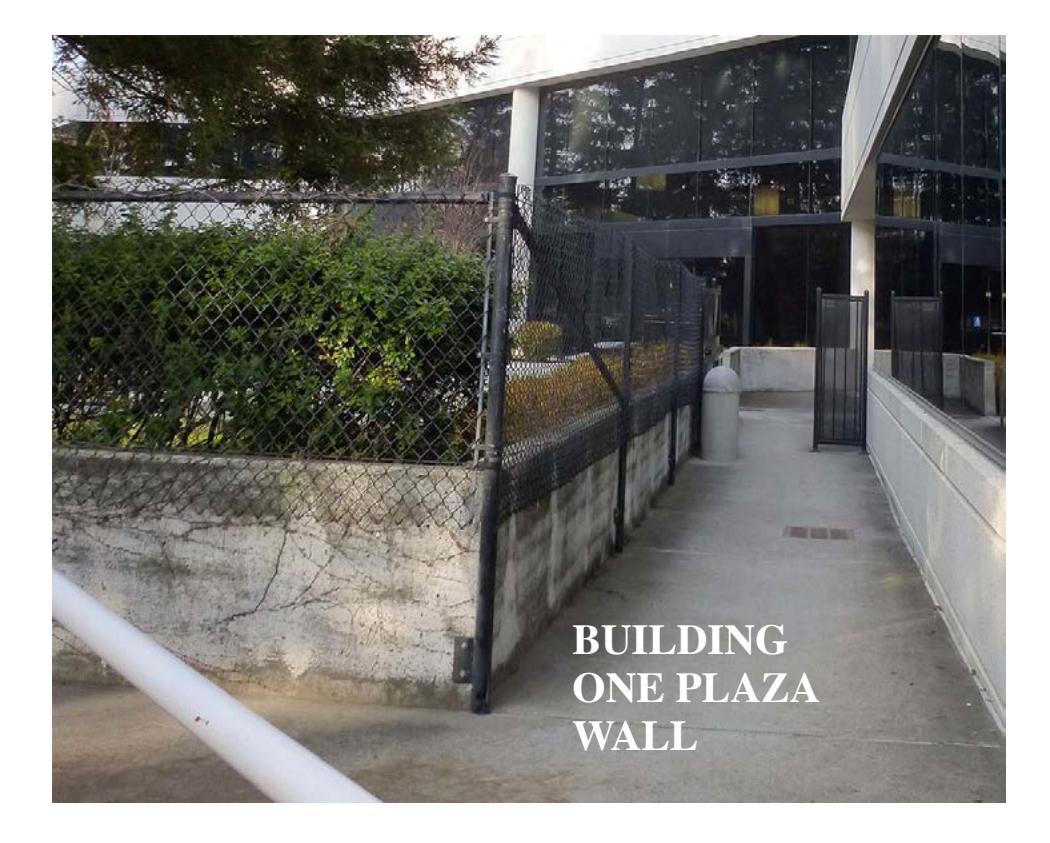
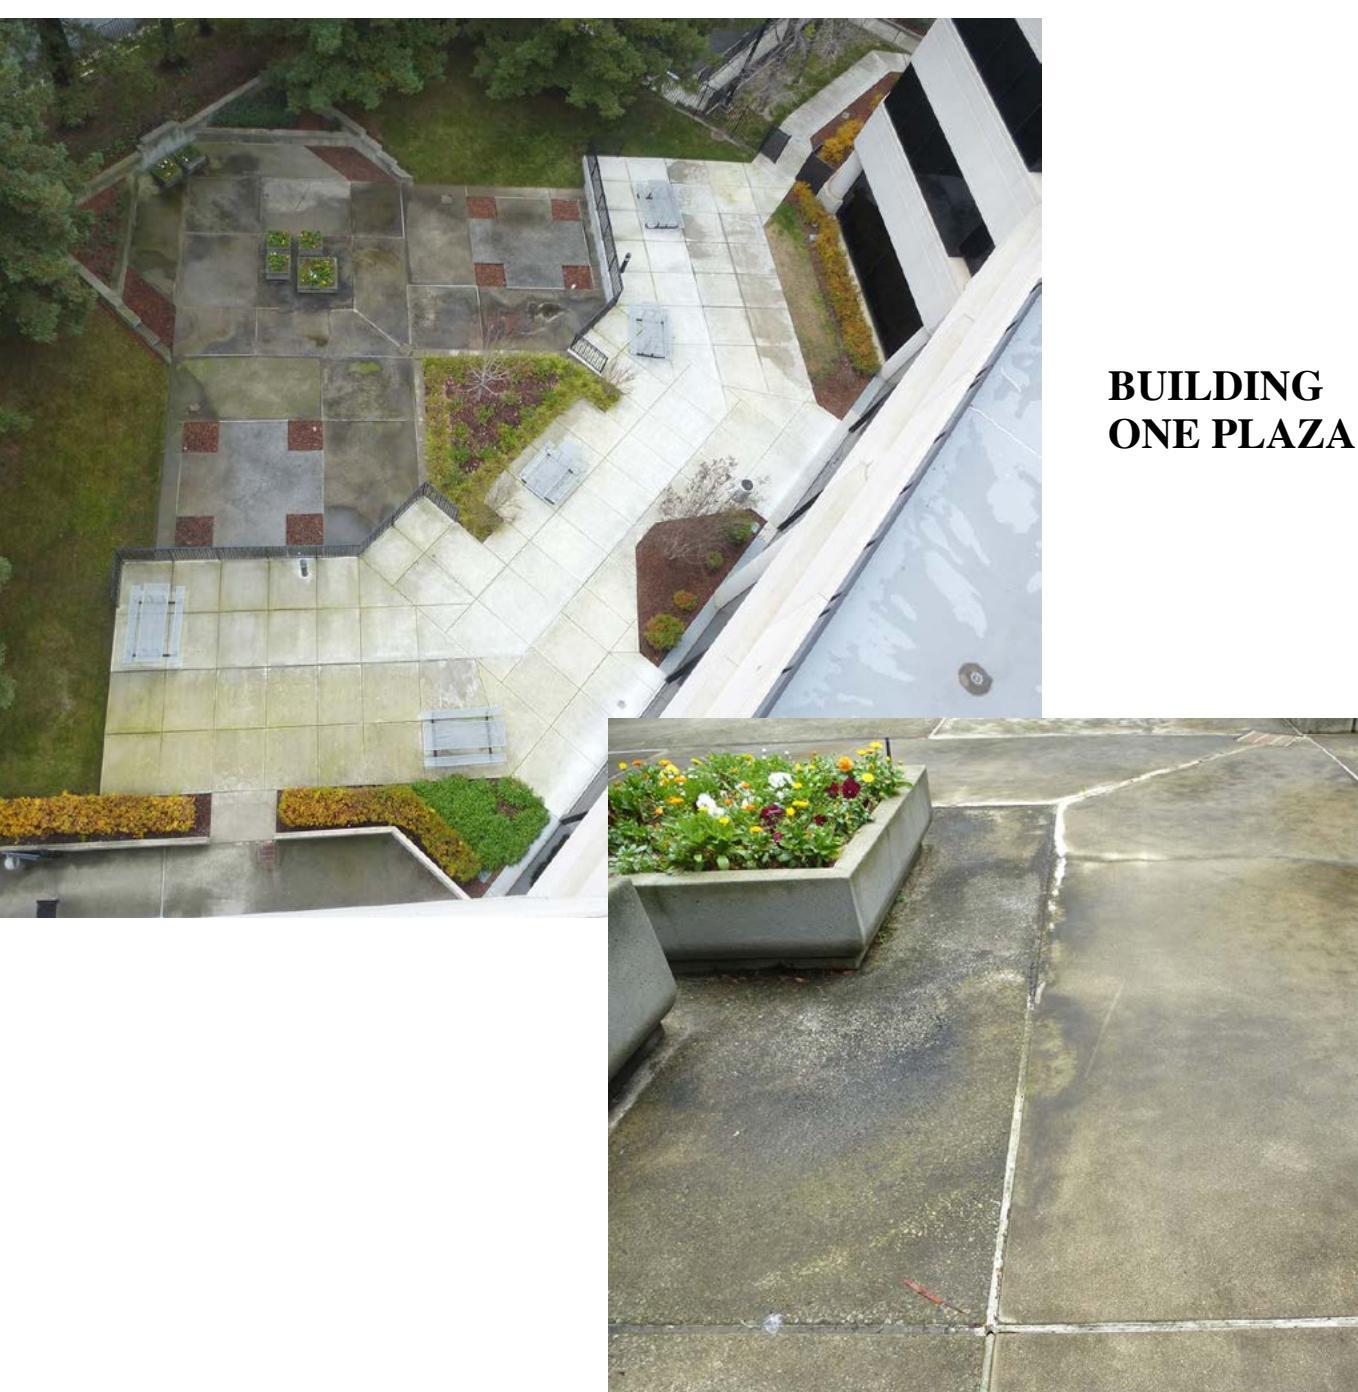
Building One Plaza walls need to be re-coated.

Building One Plaza needs, at a minimum, cleaning and sealing of all surfaces, including the planters, and restoration of all joints. These surfaces aren't in bad condition but there are cracks in some of the slabs and without remediation they will continue to deteriorate at an accelerated rate.

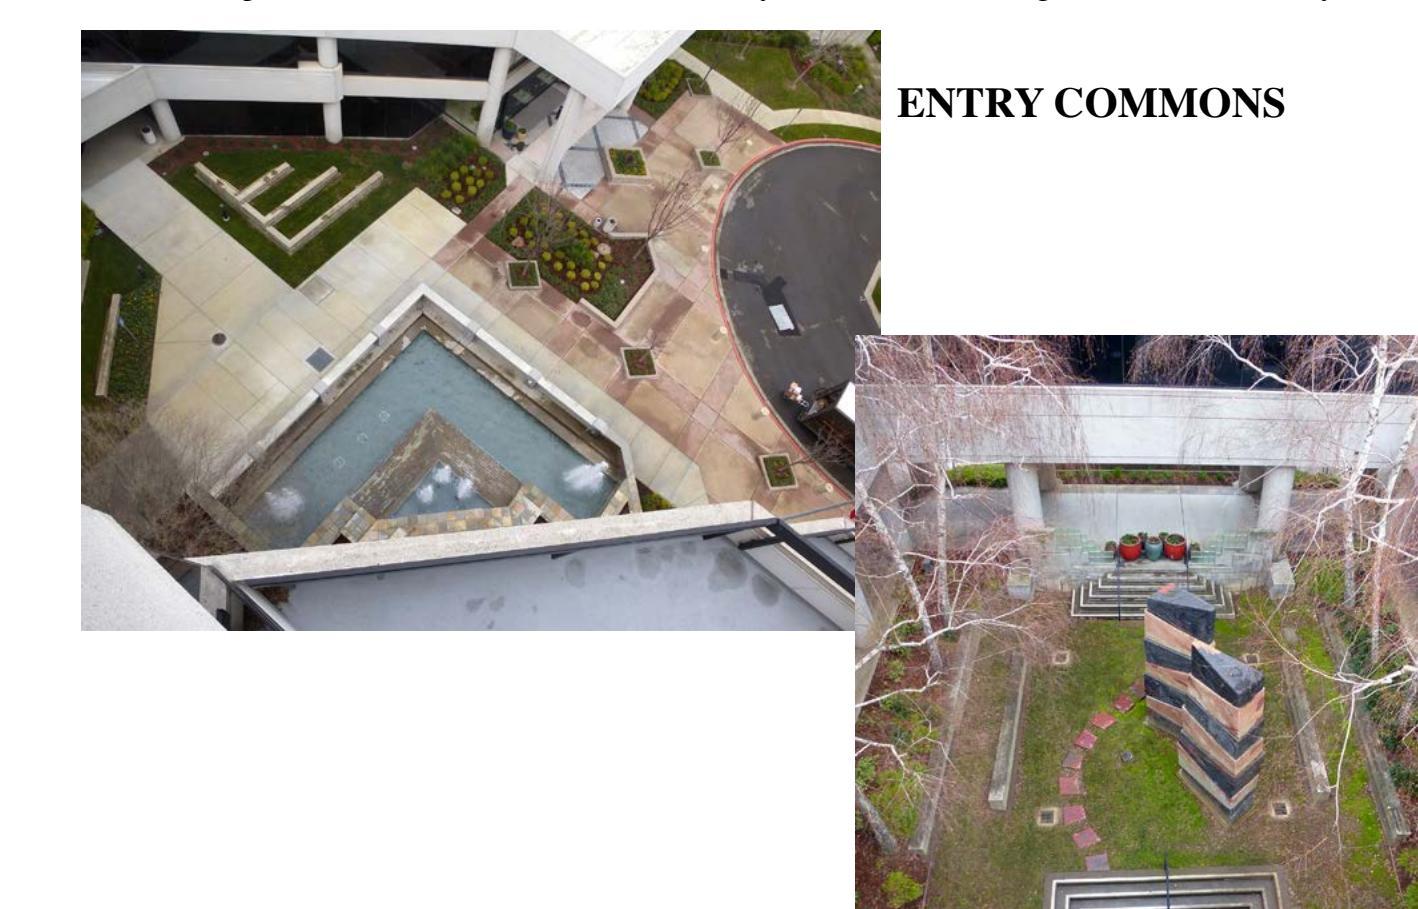
SCULPTURE GARDEN

All the surfaces in the sculpture garden should be cleaned and sealed and the joints in these structures restored. Although the sculpture is in good condition the artist should be consulted to offer advise on what should be done, if anything, to protect and preserve the piece. Mineral paint applied to the weathered, concrete elements in this area could be used to bring color and new life to the space. The artist or a designer could be consulted on this matter too. If these materials and colors were applied to the concrete surfaces in the Entry Commons the two spaces could be visually tied together.

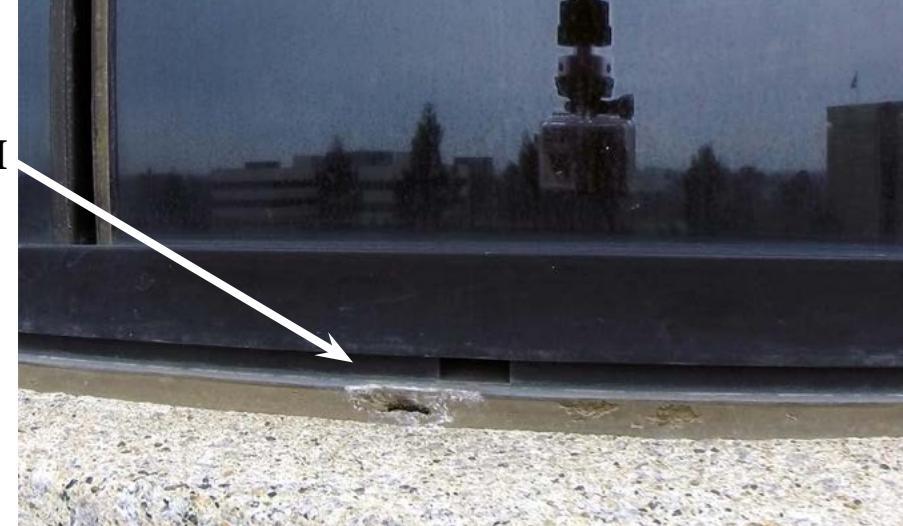
By lowering a remotely operated camera to the bottom of one of the windows in Ms McNeal's office on the 6th floor an opening in the frame perimeter joint was found. She said that at times the sill outside her office is covered with "bees". Some could have taken that path into her office.

OPENING IN 6TH FLOOR FRAME PERIMETER JOINT

Sealant restoration and installation of the proper material in the wall and window weeps will correct the insect intrusion problem completely.
