Rodney Square Building Restorations, Inc.

February 26, 2010

RE: [REDACTED] Wall Repair

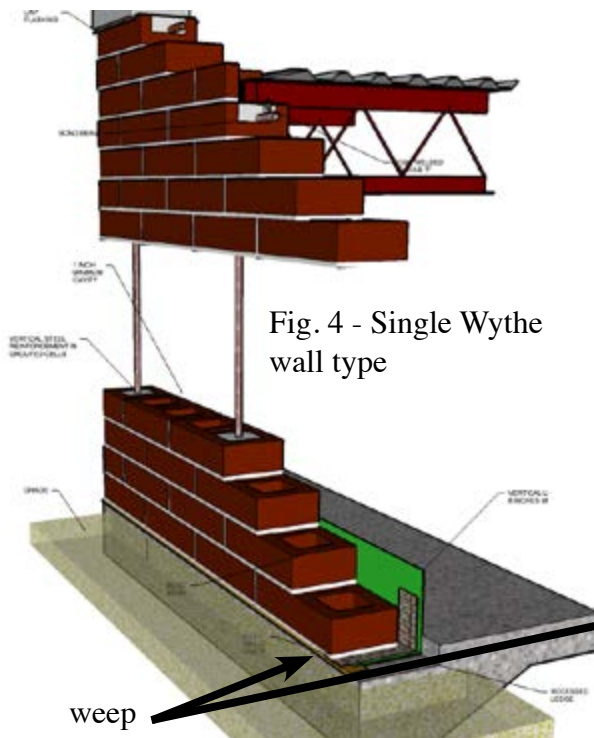
Fig. 4 - Single Wythe wall type

Although slightly different than the walls at [REDACTED], the details in Figures 4 and 5 serve to illustrate the condition mentioned that affects water infiltration.

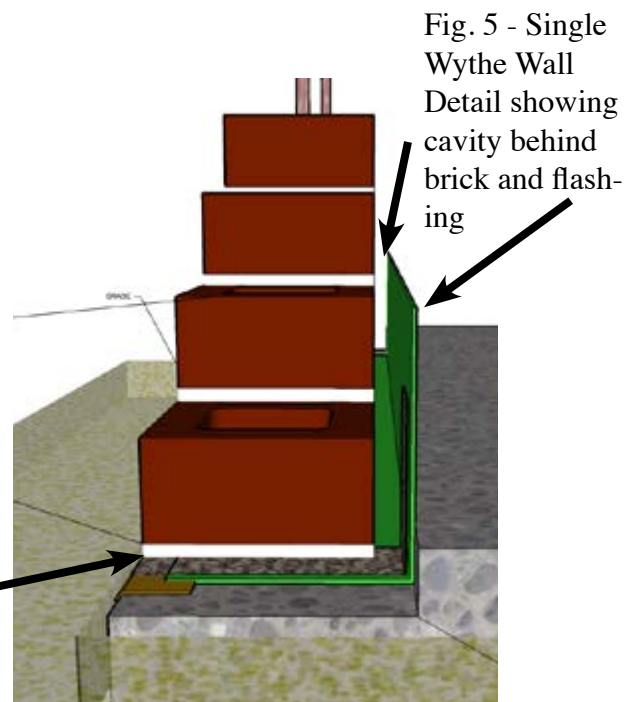
Fig. 5 - Single Wythe Wall Detail showing cavity behind brick and flashing

Note the cavity between the back of the brick and the flashing in Figure 5. A wall built as shown allows water that penetrates the brick or condenses on the back of the brick to exit the wall through weeps installed in the base.
